**BUILDING CONDITION SURVEY**

**in respect of**

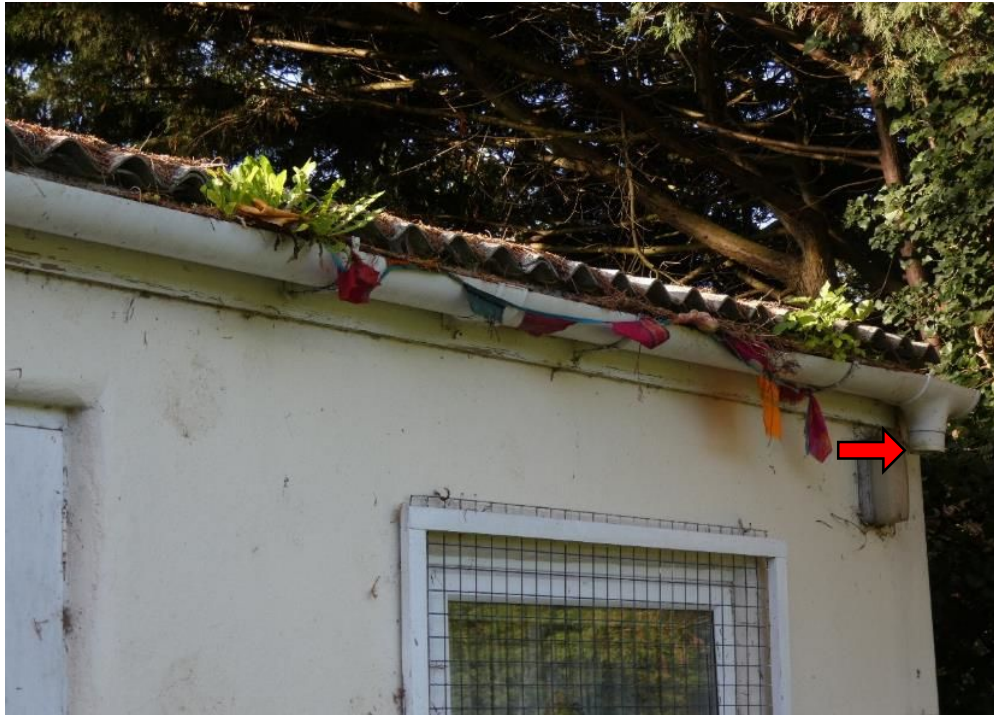
**Photograph 7:** Leaves accumulating on the roof and in gutters. Note missing front right-hand rainwater downpipe.

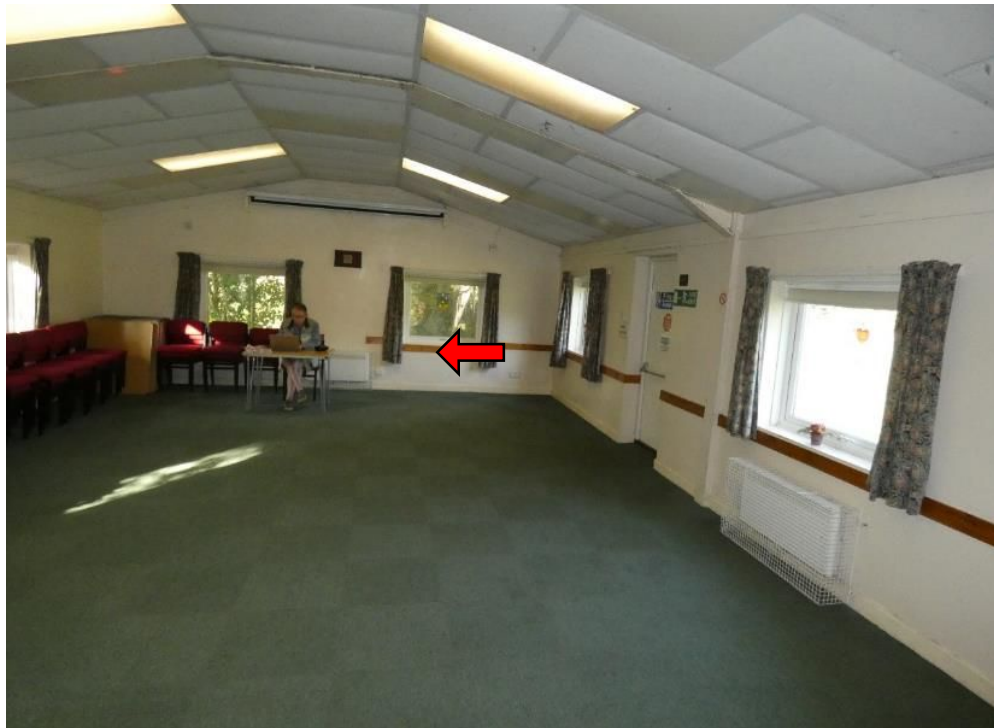
**Photograph 8:** Factory lining system to the roof of the hall.

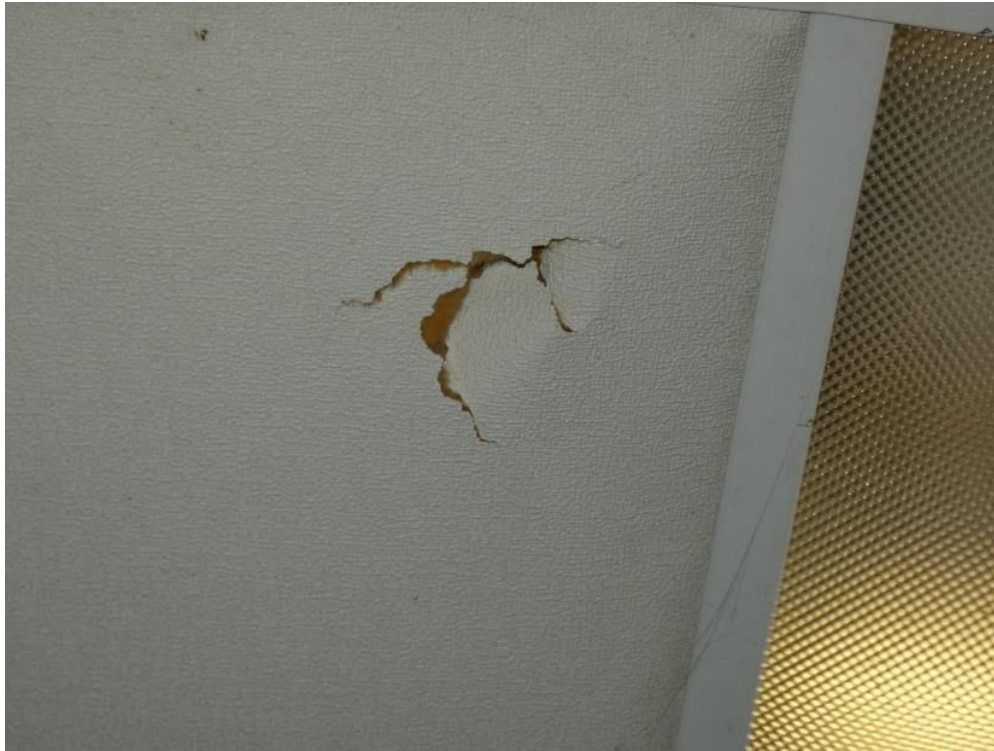
**Photograph 9:** Damaged tile to the factory lining system.

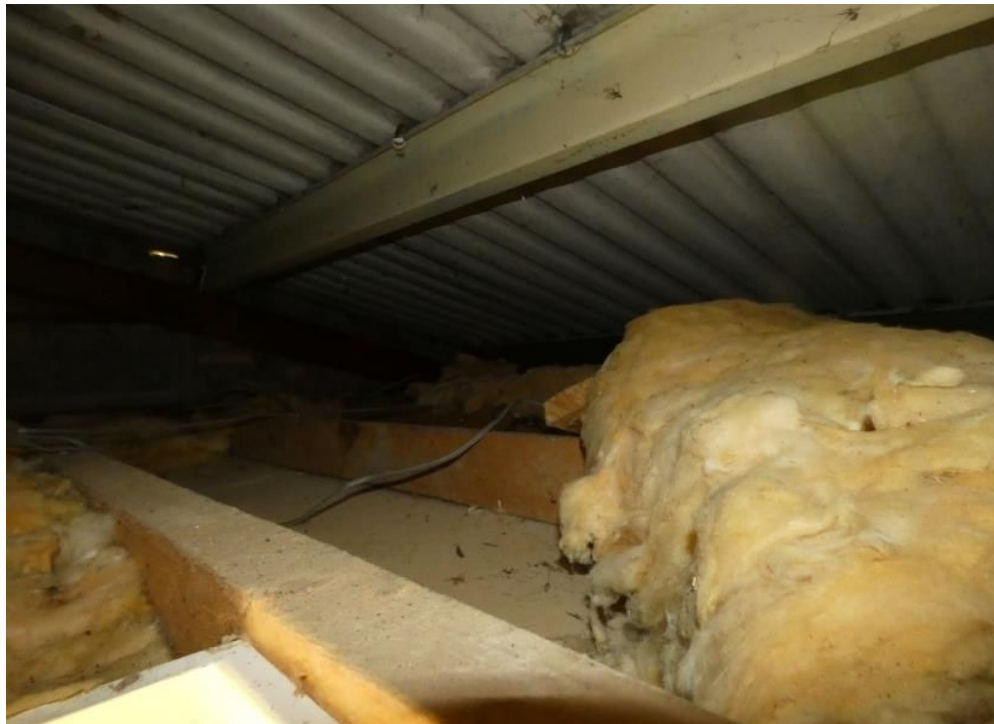
**Photograph 10:** Poorly distributed insulation in the roof void.

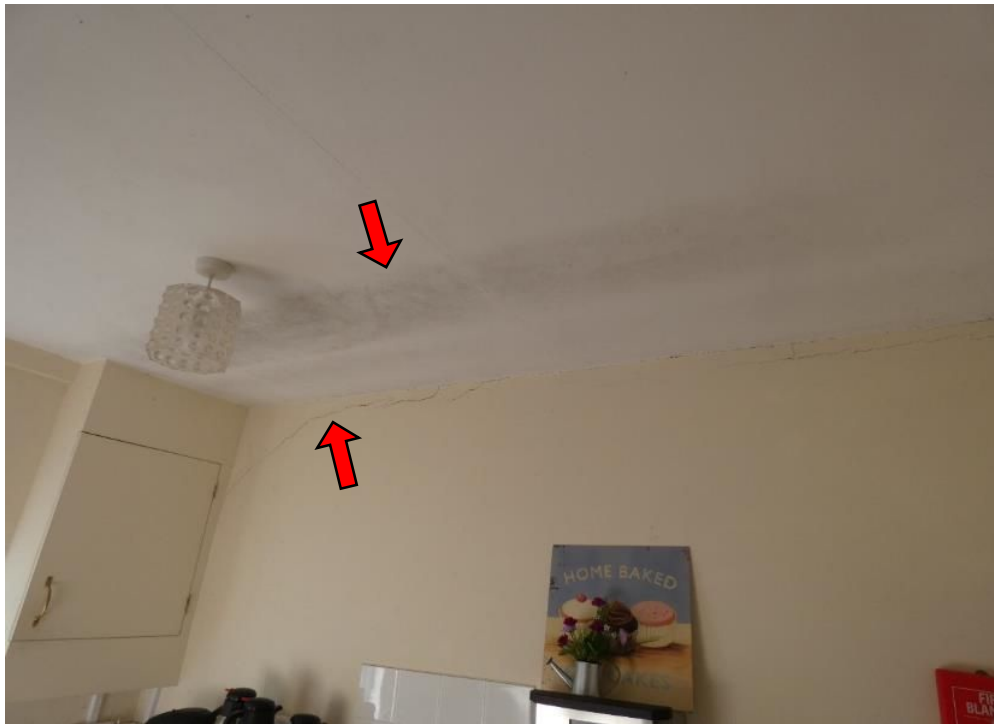
**Photograph 11:** Condensation mould to the kitchen ceiling and crack to the rear left-hand corner.

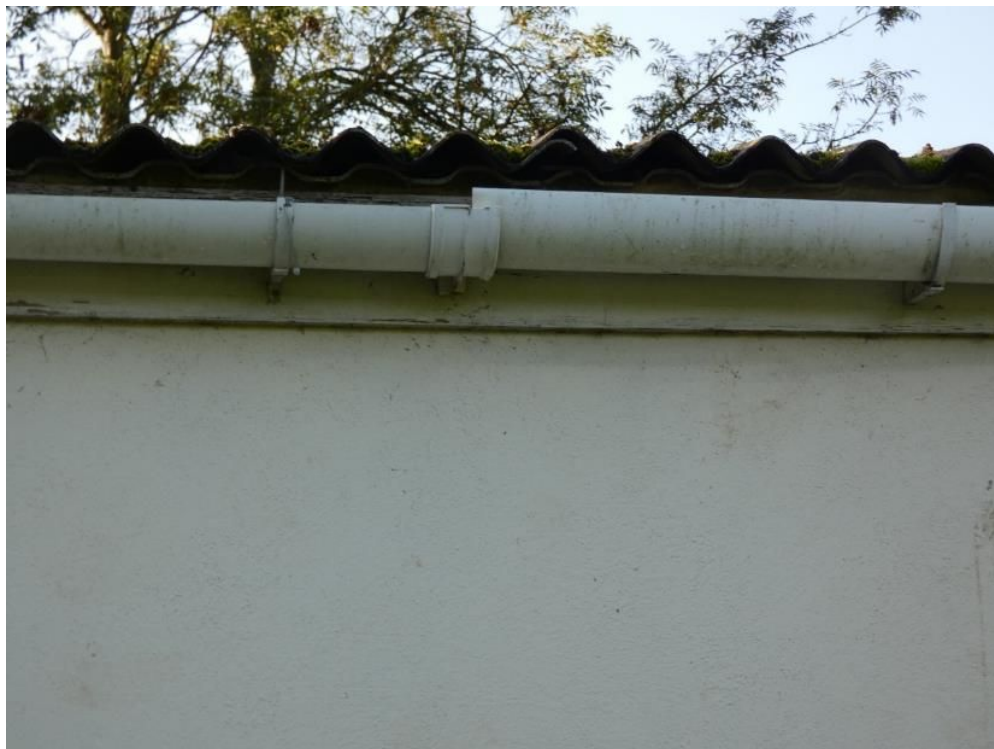
**Photograph 12:** Defective joint to the front rainwater gutter.

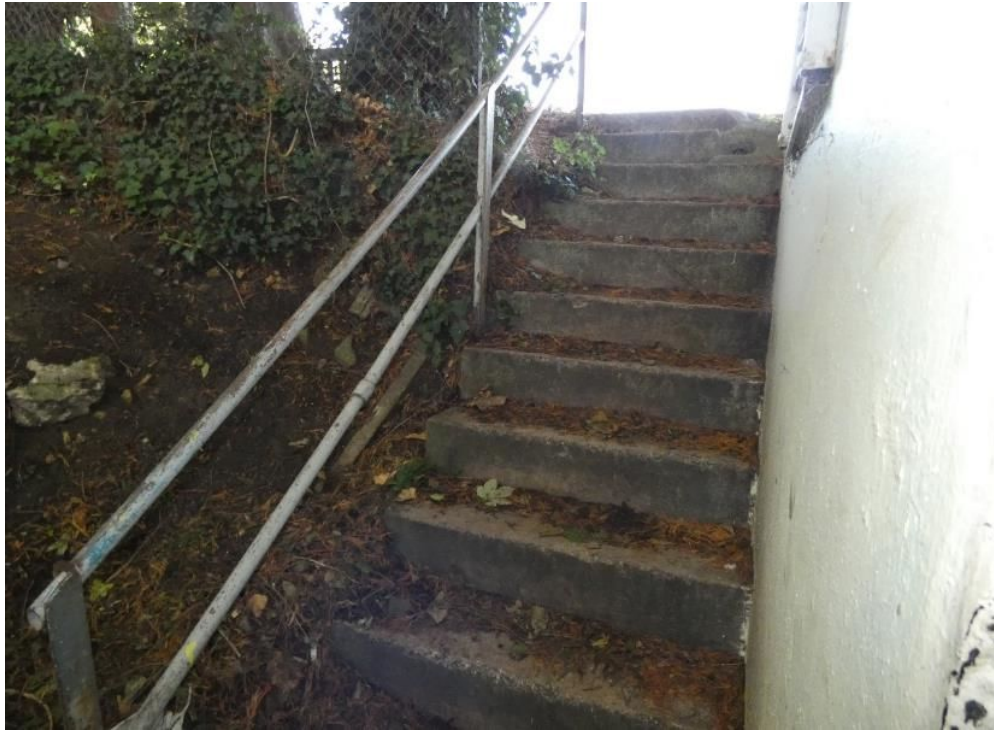
**Photograph 13:** External steps to the right-hand side.

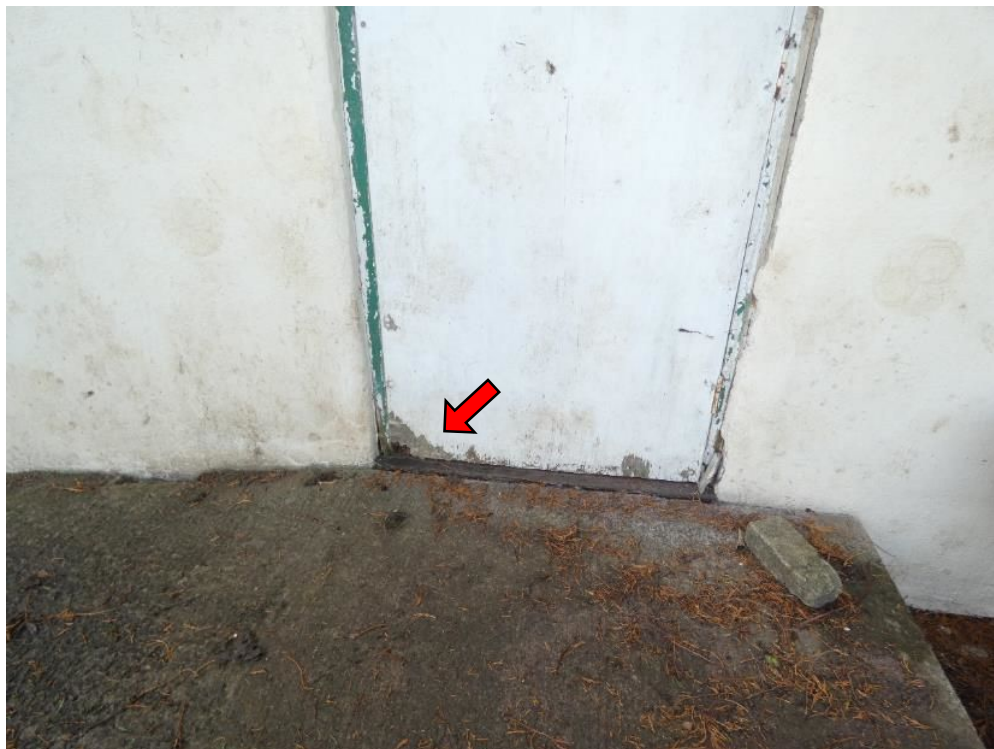
**Photograph 14:** Rot to the base of the front right-hand door.

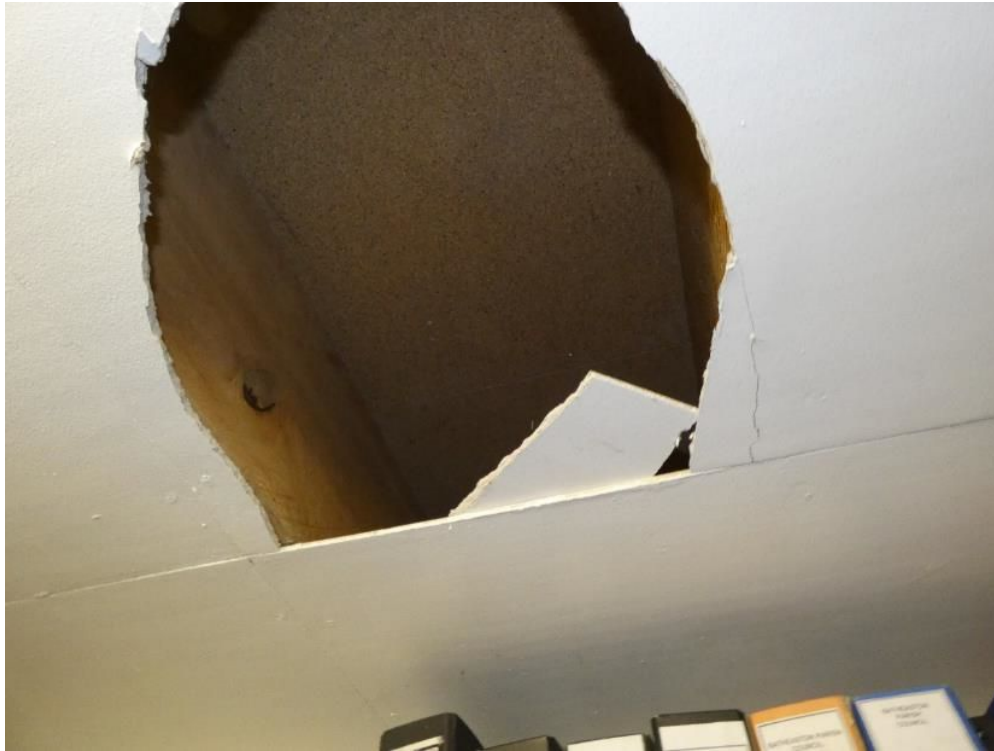
**Photograph 15:** Hole in the cementitious ceiling board to the changing rooms.
